Manhole Inspection Summary

Manhole # S63O__005MH

Insp Date: **8/31/09 12:48 PM**

Location Address: **Boston St.**

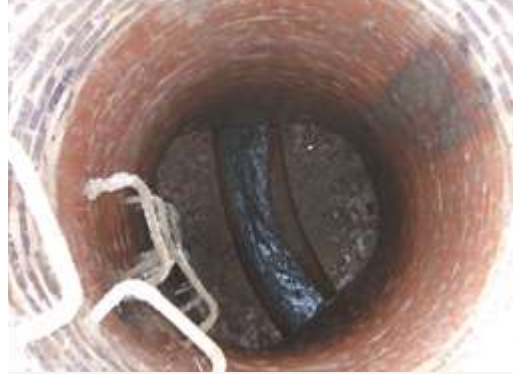
Top View

Comments **NRV2 - RAISED TO GRADE ON 8/20/09 BY REI [RES] BURIED, VERIFIED BY CCTV: 0806, SETUP K0016, VIDEO DU-K0016 . VERY LIGHT ROOTS IN CHIMNEY.**

Condition: ☐ Sound ☐ Cracked ☐ Root Intrusion ☐ Loose Brick ☒ **Deteriorated**

Infiltration: ☐ None ☐ Joint ☐ Cracks ☒ **Mortar** ☒ **Roots** ☐ Wall

Condition: ☐ Sound ☐ Cracked ☐ Root Intrusion ☐ Deteriorated ☐ Leaks ☒ **Debris**

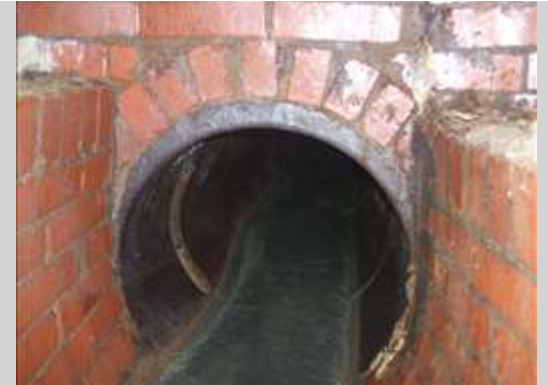
12 O'Clock Outflow

21 in. Circular Gravity Sewer
Pipe Out @ 12 O'Clock

Pipe Height: (in.) Direct
Pipe Material: **Clay** ☐ Pipe Lined
Invert Depth: **20.56** (ft.) Flow Characteristics: **Fast**
Deposits: ☒ None ☐ Mud ☐ Sludge ☐ Debris ☐ Grease
Silt Depth: (in.) Deposits Extent:
Infiltration: **None** Pipe Seal Cond: **Sound**

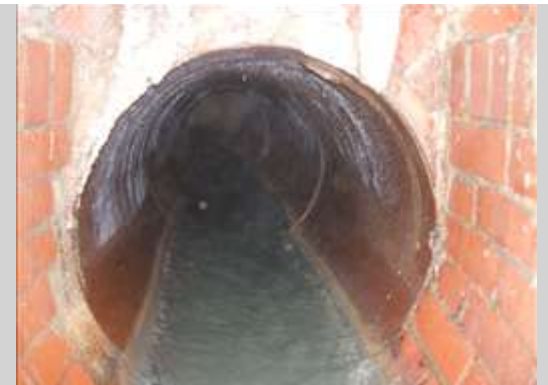
4 O'Clock Inflow

21 in. Circular Gravity Sewer
Pipe In @ 4 O'Clock

Pipe Height: (in.) Direct
Pipe Material: **Clay** ☐ Pipe Lined
Invert Depth: **20.30** (ft.) Flow Characteristics: **Fast**
Deposits: ☒ None ☐ Mud ☐ Sludge ☐ Debris ☐ Grease
Silt Depth: (in.) Deposits Extent:
Infiltration: **None** Pipe Seal Cond: **Sound**
